'Patriot shootdown of a Kinzhal': dezinformatsiya?

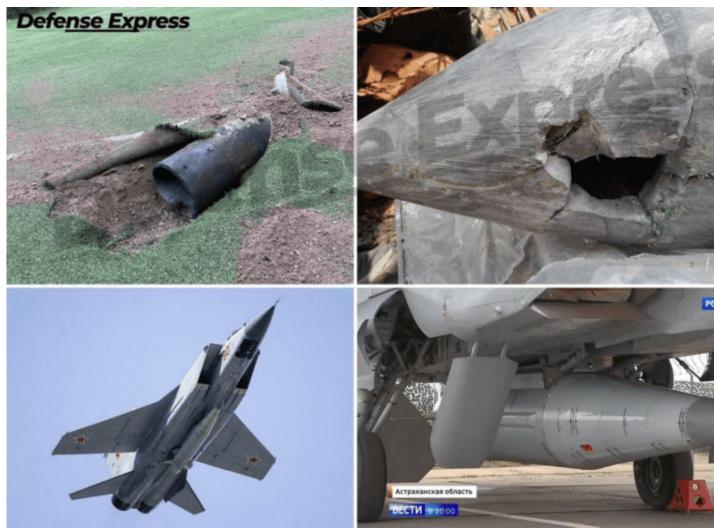
Photo of alleged downed Kinzhal missile and close-in photo of where it was supposedly hit. Note the photo of the downed "Kinzhal" missile looks staged and is different from known images of the front section of the Kinzhal. Photo: Defense Express

The photo supplied by Ukraine of the alleged nose section of the Kinzhal with a roundish hole in it was not likely hit either by a kinetic kill or by the missile's lethality enhancer.

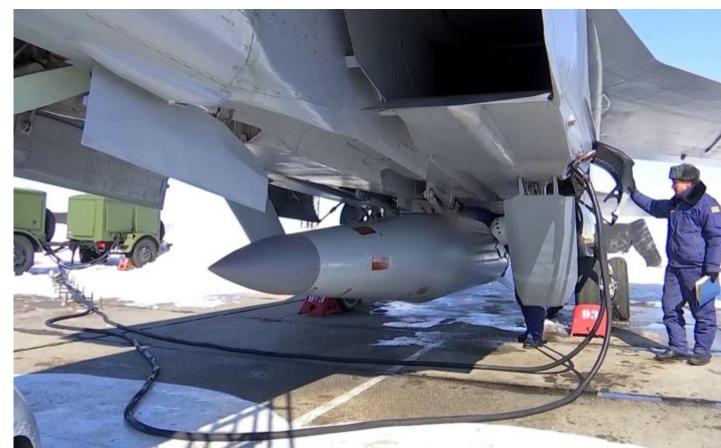
Under the belly of a Russian Aerospace Forces MiG-31 is a Kinzhal hypersonic aeroballistic missile with a small radar signature and high maneuverability. Photo: Ministry of Defense of the Russian Federation

The Kinzhal has a solid-fuel rocket motor and is launchable from either a Tu-22M3 nuclear bomber or a MIG-31 interceptor. When fired from the Tupolev bomber, the Kinzhal has a range of 3,000 km. When fired from a MIG-31, the range is less, around 2,000 km, perhaps due to a less capable onboard radar. The Tu-22M3s are stationed in the southern and western districts of Russia, putting them in range of Kiev and other Ukrainian targets.
